CITIZENS PROPERTY INSURANCE CORPORATION
BUILDING TYPE II AND III MITIGATION INSPECTION FORM

WIND LOSS MITIGATION INFORMATION			
PREMISES #:		SUBJECT OF INSURANCE: Beach Walk East Condominium Association, Inc.	POLICY #:
BUILDING #:	3201	STREET ADDRESS: 3201 S. Ocean Blvd Highland Beach, FL 33487	
# STORIES:	12	BLDG DESCRIPTION: 3201 S. Ocean Blvd	
BUILDING TYPE: <input type="checkbox"/> II (4 to 6 stories) <input checked="" type="checkbox"/> III (7 or more stories)

Inspection Photos

3201 S. Ocean Blvd

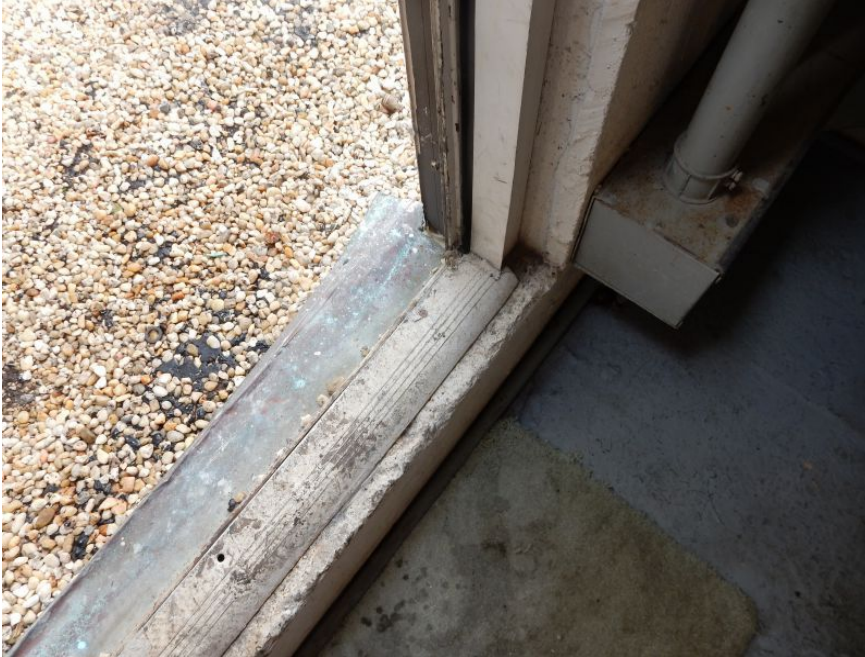
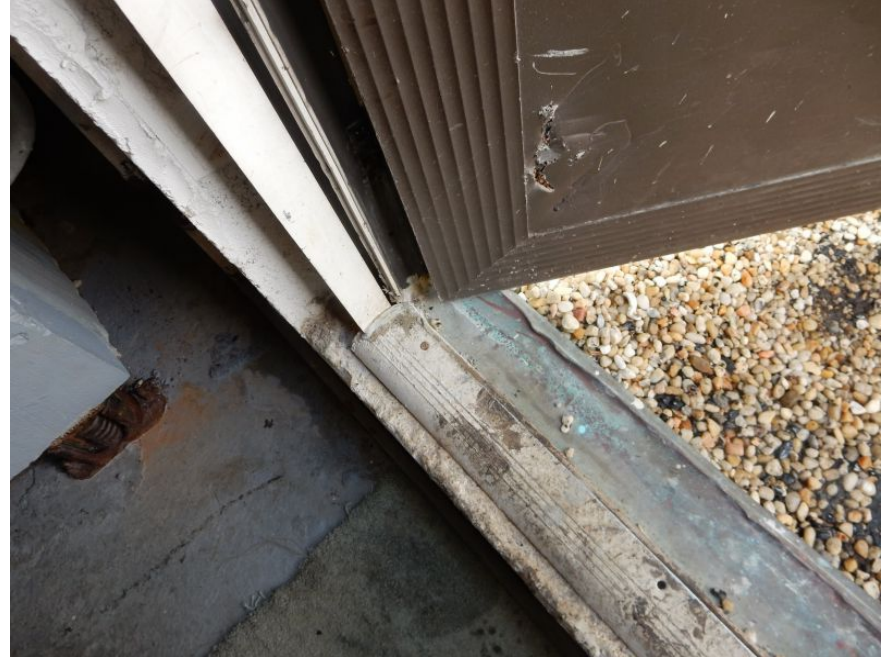
☒ **Level C – Reinforced Concrete Roof Deck Type, II or III**

A roof structure composed of cast-in-place or pre-cast structural concrete designed to be self-supporting and integrally attached to wall/support system.

Reinforced Concrete Roof Deck

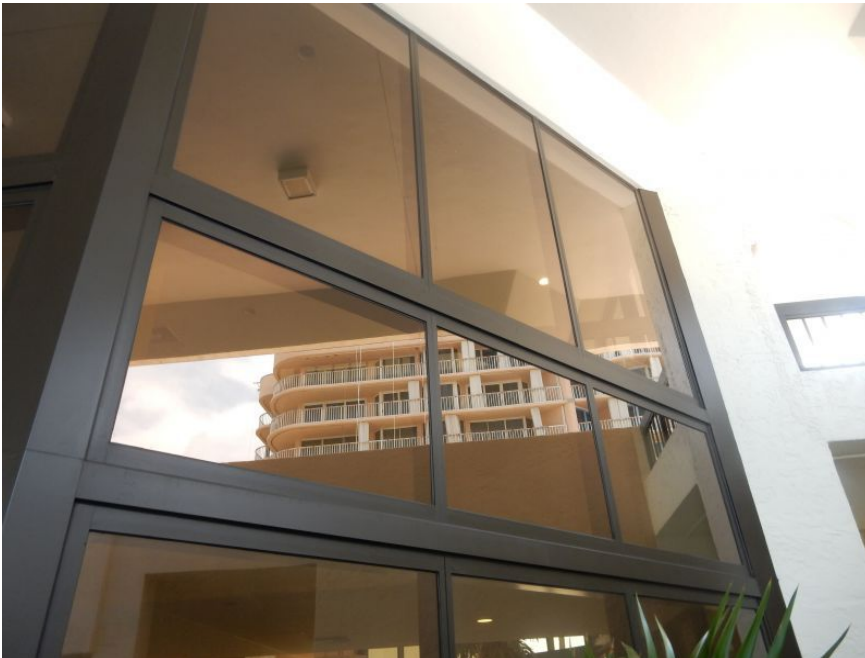
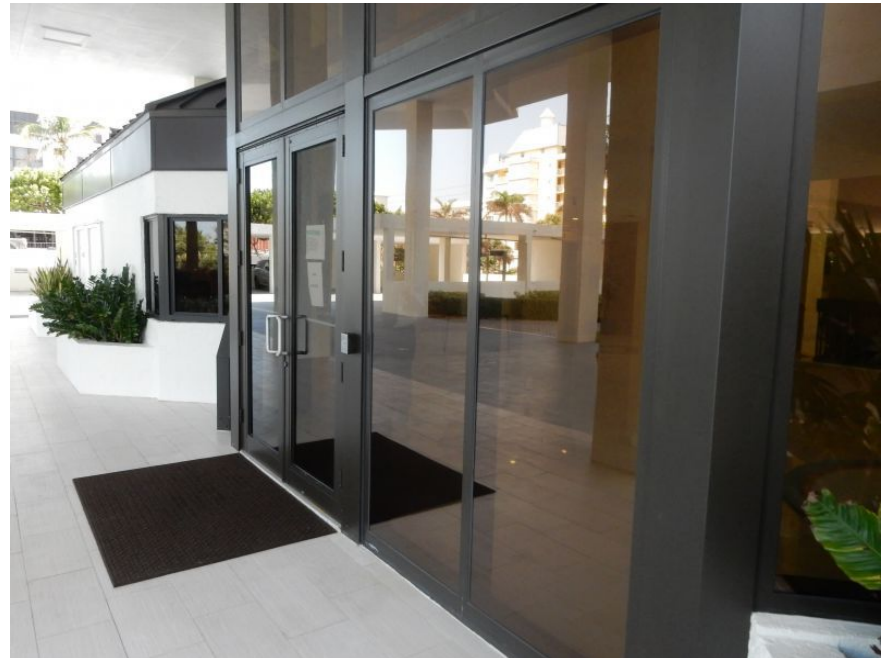
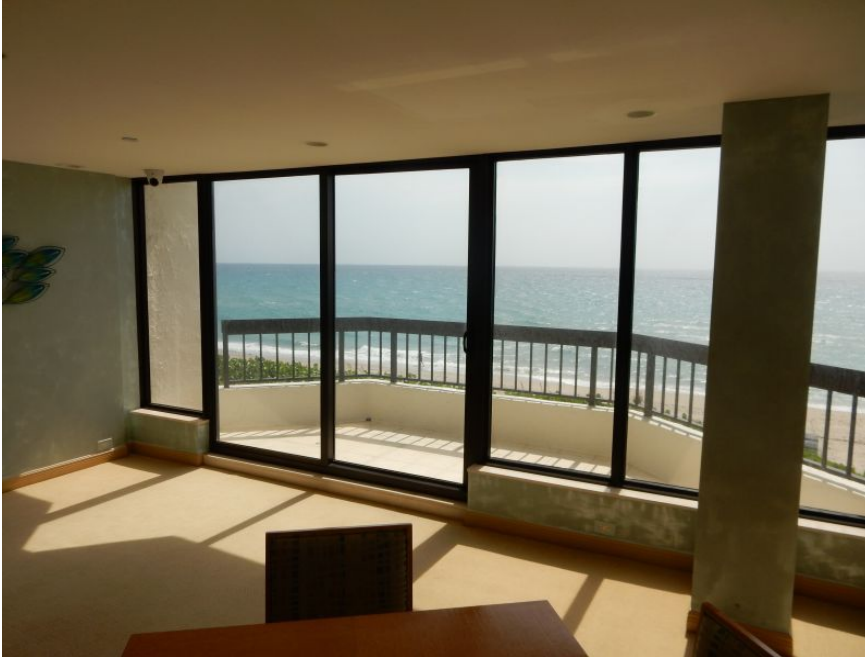
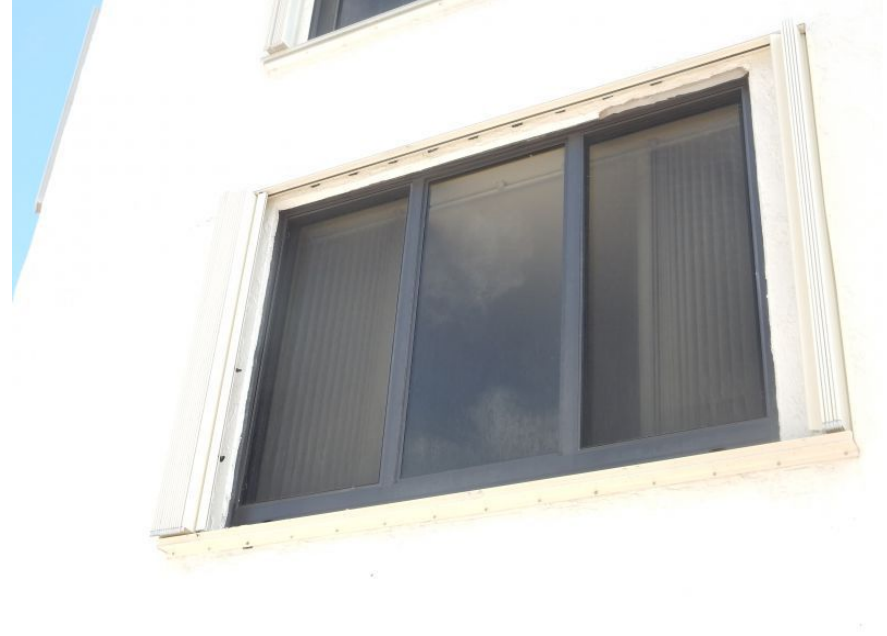
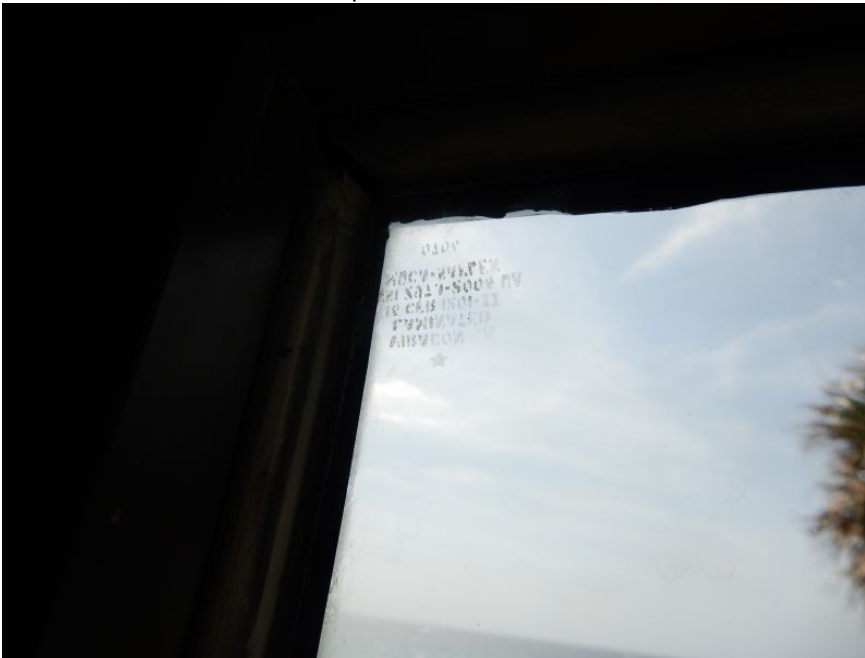
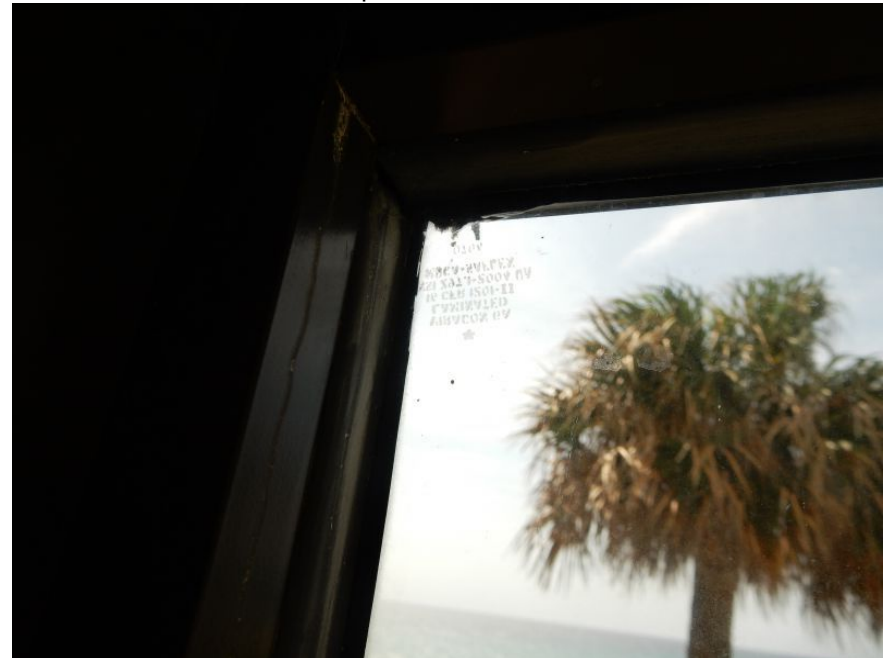
☒ **Class A (Hurricane Impact)** – All glazed openings (windows, skylights, sliding glass doors, doors with windows, etc) less than 30 feet above grade must be protected with impact resistant coverings (e.g. shutters), impact resistant doors, and/or impact resistant glazing that meet the Large Missile (9 lb.) impact requirements of:

☒ **Miami-Dade PA 201, 202, and 203;**

Impact Glass

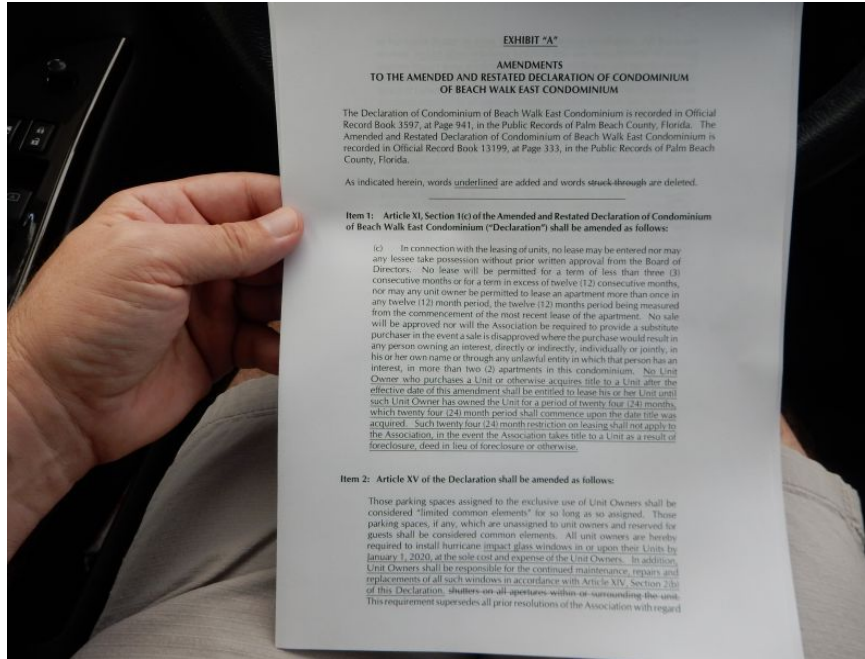
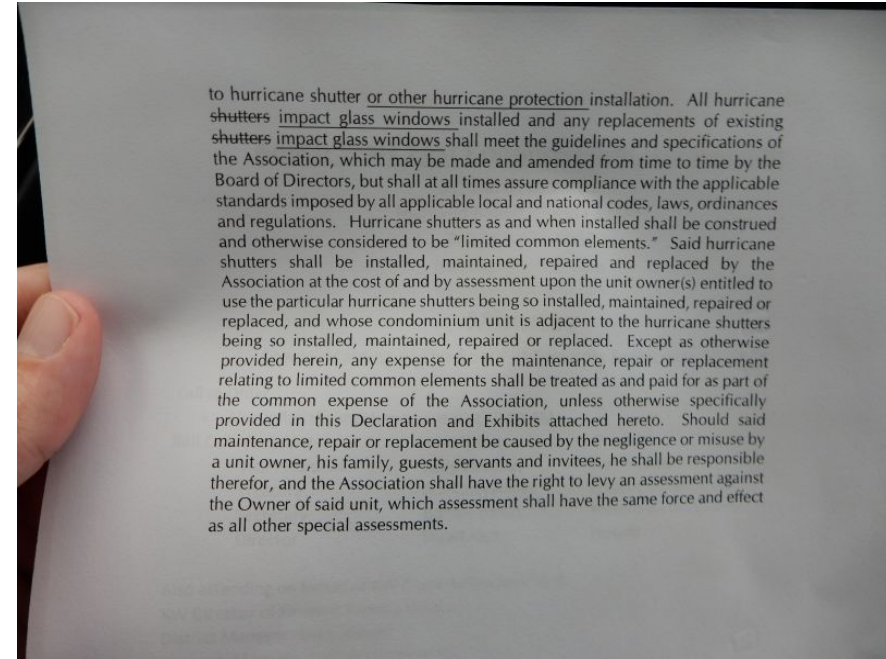
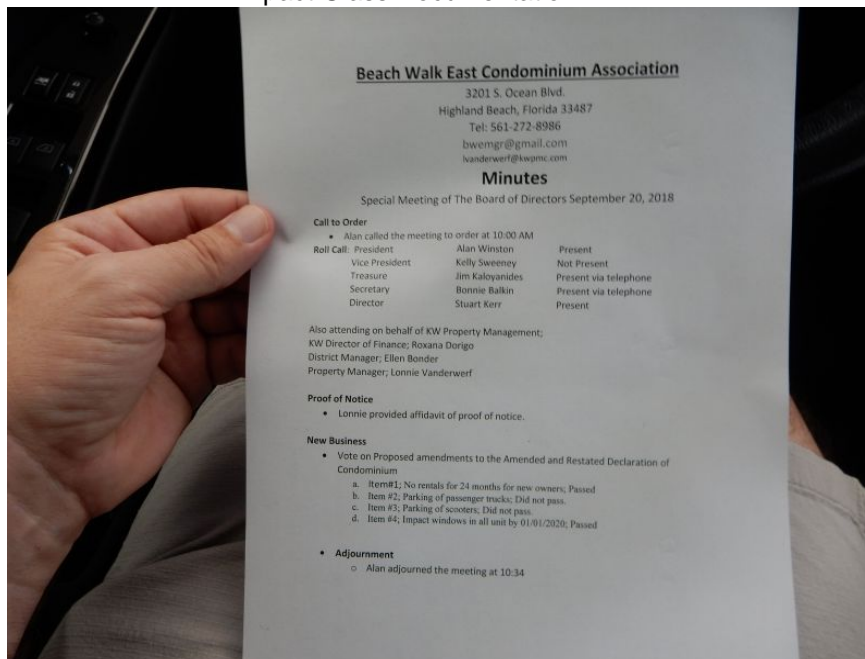
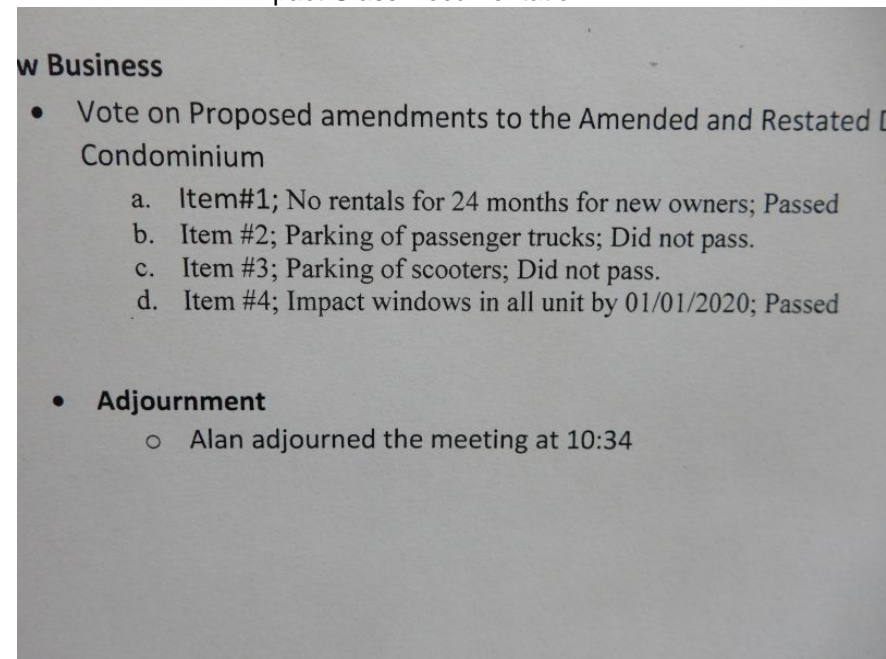
Impact Glass Documentation

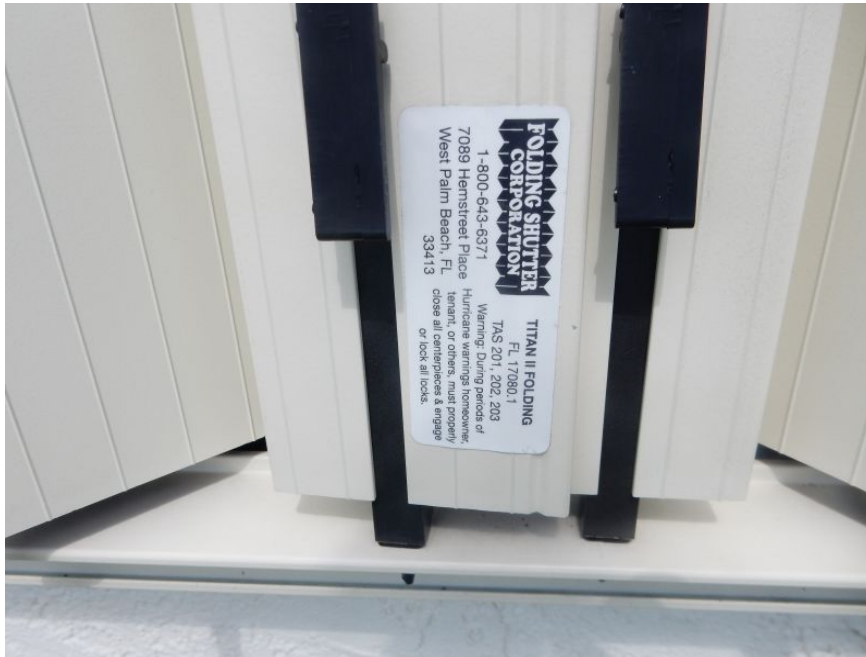
Impact Rated Accordion Shutter Label

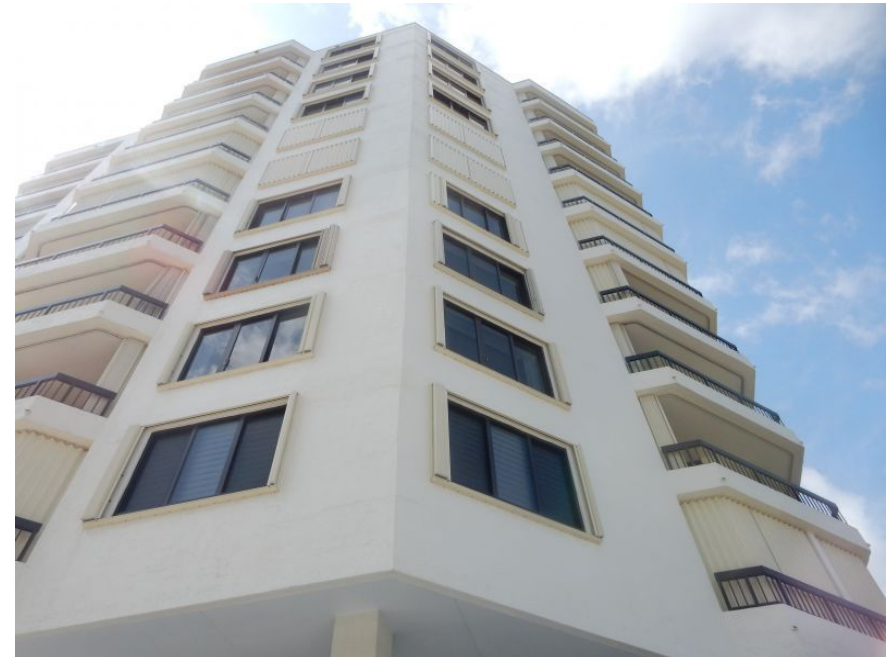
Impact Rated Accordion Shutters

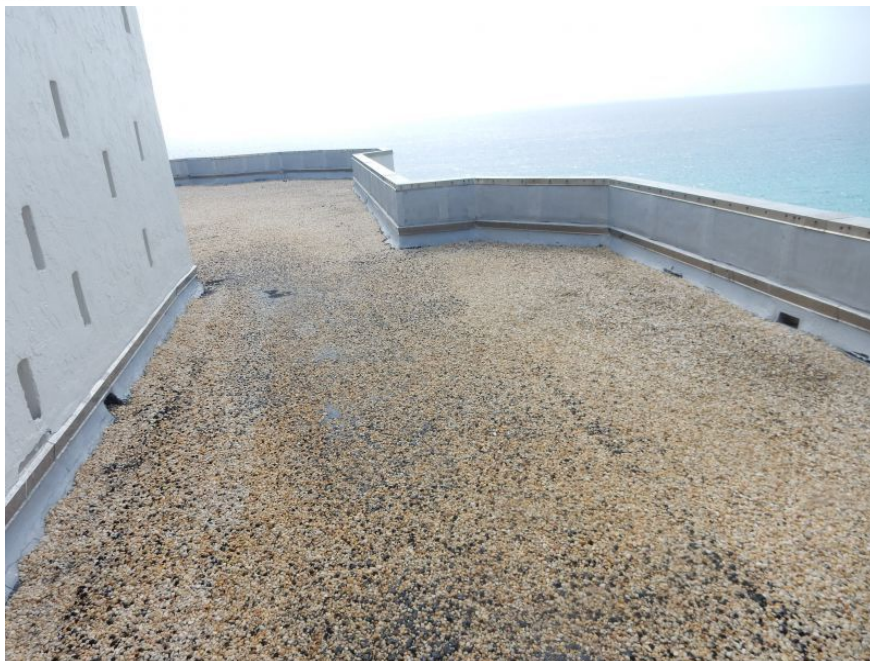
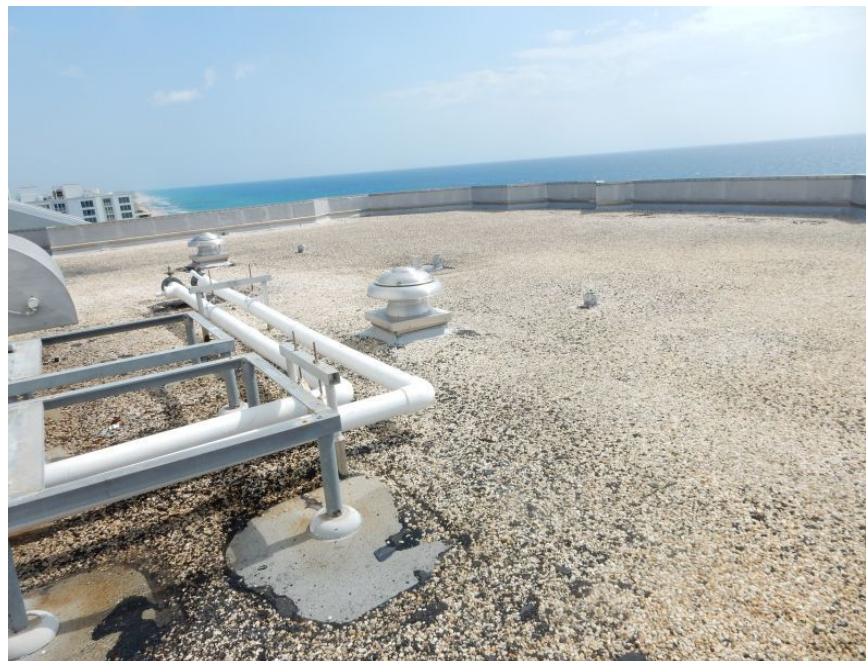
1.	Roof Coverings
Roof Covering Material: <u>Tar & Gravel (Flat)</u> Date of Installation: <u>2006 (RF-21947, 5/15/2006)</u>	
<div style="margin-left: 20px;"><input type="checkbox"/> Level A (Non FBC Equivalent) – Type II or III One or more roof coverings that do not meet the FBC Equivalent definition requirements below.</div> <div style="margin-left: 20px;"><input checked="" type="checkbox"/> Level B (FBC Equivalent) – Type II or III Single-Ply, Modified Bitumen, Sprayed Polyurethane foam, Metal, Tile, Built-up, Asphalt Shingle or Rolled Roofing, or other roof covering membranes/products that at a minimum meet the 2001 or later Florida Building Code or the 1994 South Florida Building Code and have a Miami-Dade NOA or FBC 2001 Product Approval listing that is/was current at the time of installation. All mechanical equipment must be adequately tied to the roof deck to resist overturning and sliding during high winds. Any flat roof covering with flashing or coping must be mechanically attached to the structure with face fasteners (no clip/cleat systems), and asphalt roof coverings on flat roofs must be 10 years old or less.</div>

Built-Up Tar & Gravel Roof Covering
